No. 8

P.N. Garuda Indonesian Airways, Lockheed Electra L-188C, PK-GLB, accident at Mapanget Airport, Menado, Indonesia, on 16 February 1967.  
Report, not dated, released by the Civil Air Transport Board, Ministry of Communications, Indonesia

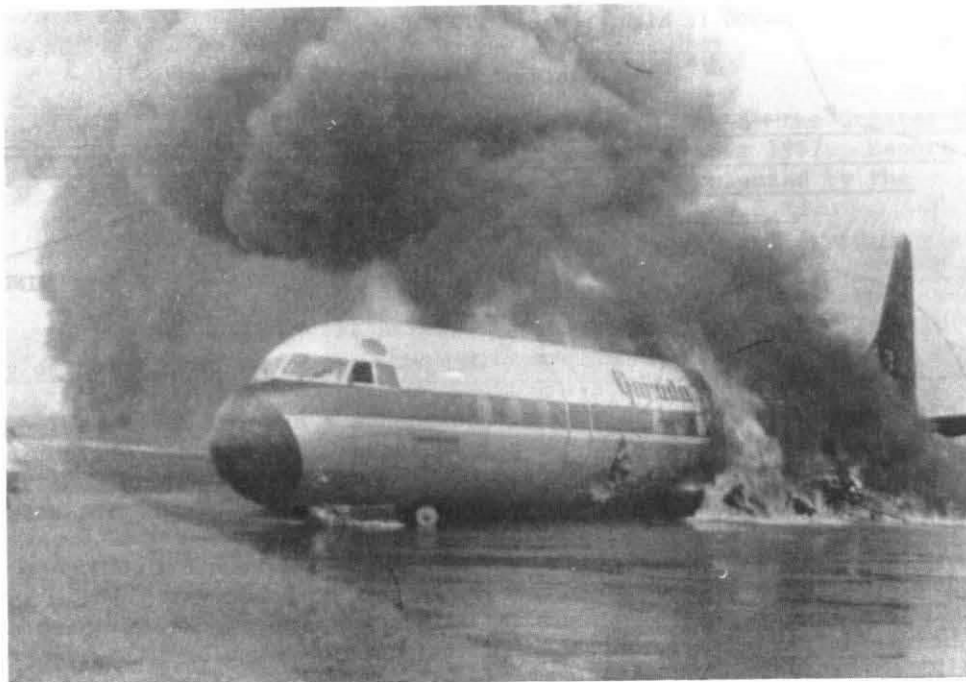
The separation of the left wing which caused the spilling of fuel from the wing tank, accompanied by the heat of the engine and also the heat produced by the friction between the aircraft body and the ground, could all have set the aircraft afire.

Figure 8-1. PK-GLB fuselage at standstill 225° heading, left wing separated. Spilled fuel burned fiercely. Note fuselage damage by No. 2 propeller.

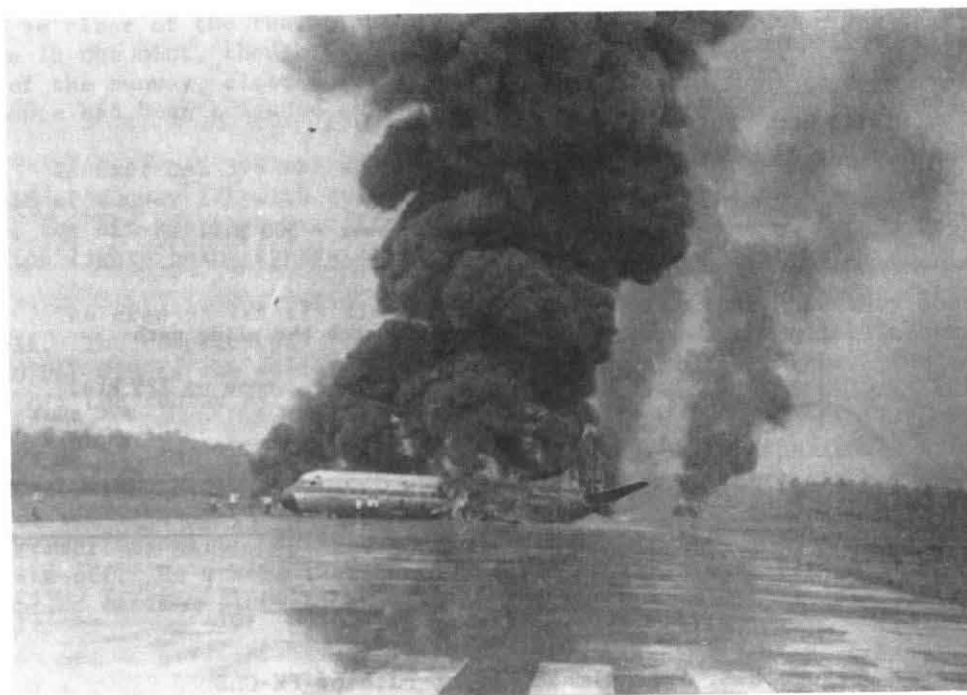
According to the crew, just after the aircraft came to a full stop the co-pilot instructed the flight engineer and the cabin attendants to open the forward main entrance door but unfortunately they did not succeed in opening this door from the inside. Meanwhile smoke and fumes began to penetrate the first class cabin (aft). The cabin attendants advised all passengers to proceed forward in order to escape from the right hand forward emergency exit and cockpit sliding windows. One of the cabin attendants tried to open the overwing emergency exits but was advised by another crew member not to open them because of fire outside the window. During that same time the flight crew attempted to open the forward main entrance door from the outside; however, they did not succeed either. Survivors evacuated from the aircraft through the right forward emergency exit and the cockpit sliding windows.

Figure 8-2. Over-all view a few minutes after the accident. Flight crew at main entrance door in attempt to open it. Note separated left wing still burning at far side. Empenage structure broke from main fuselage.

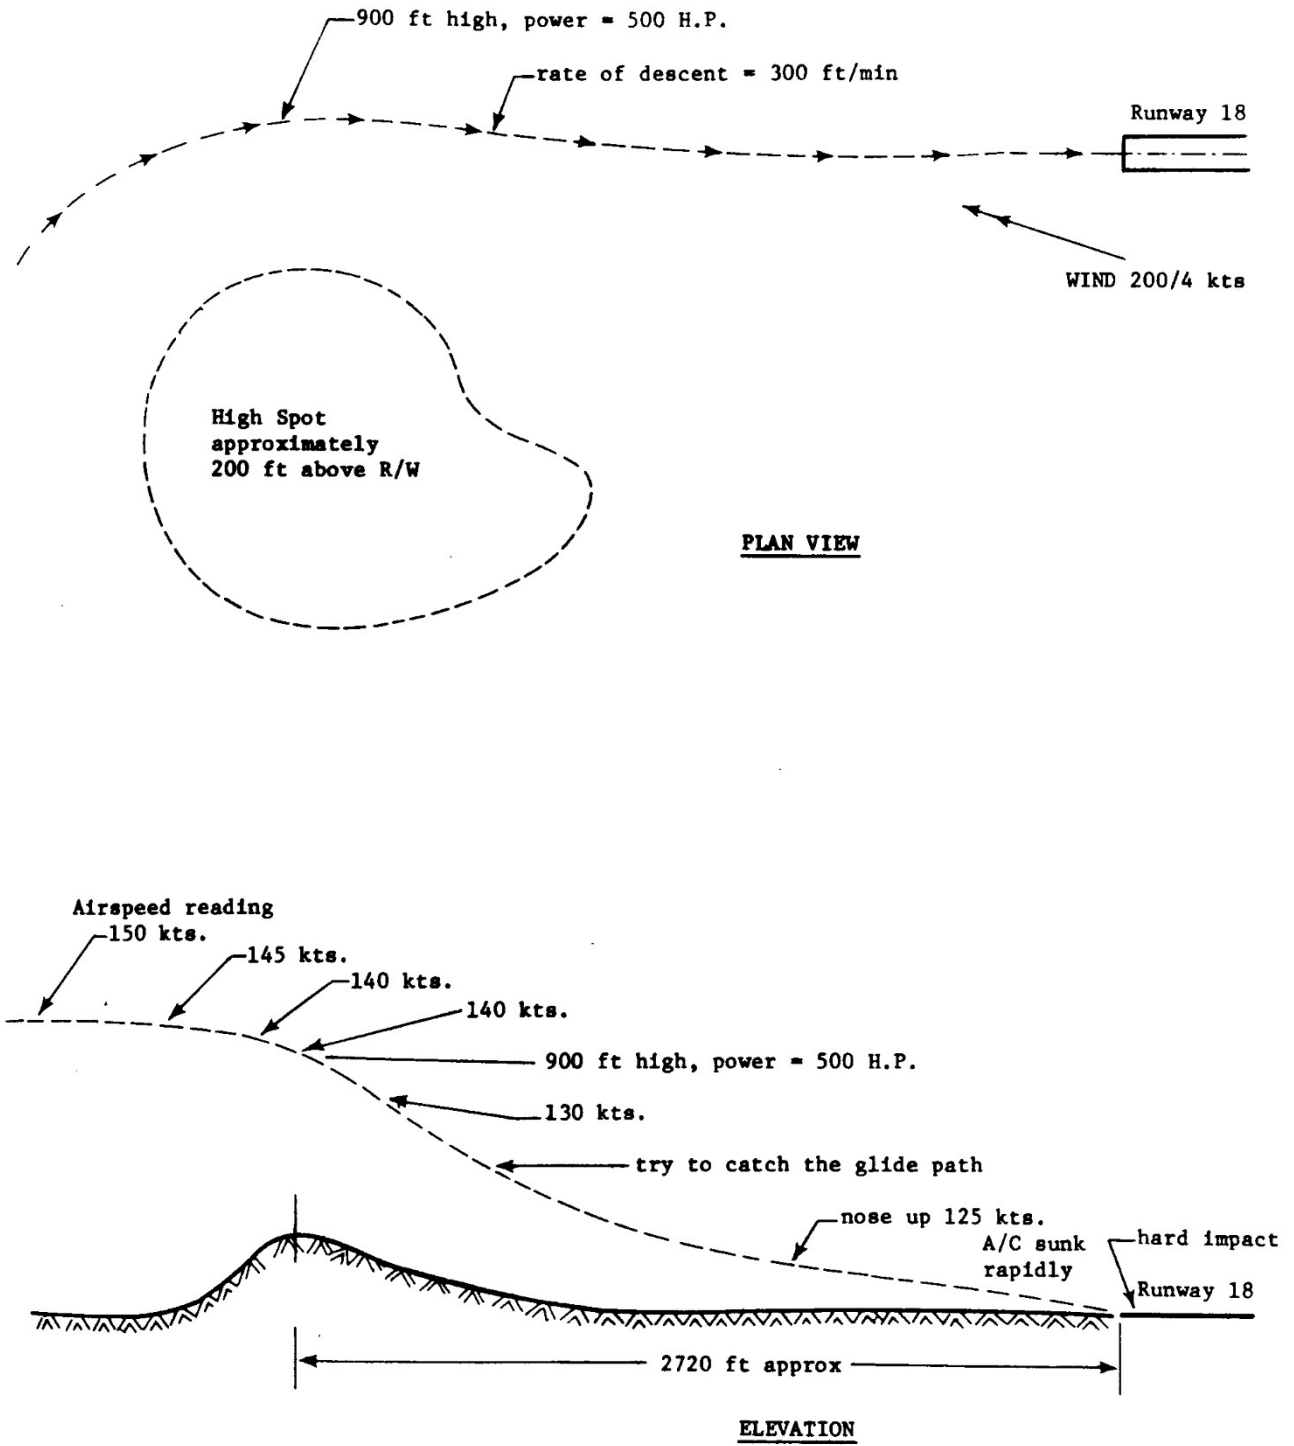
Figure 8-3. Approximate Flight Path of PK-GLB  
Mapanget Airport, Manado, 16 February 1967
